# Emergency Railroad Track Stabilization

Near Milepost 206.8 on the Orange Subdivision

# Anaheim Canyon Metrolink Station Improvement Project

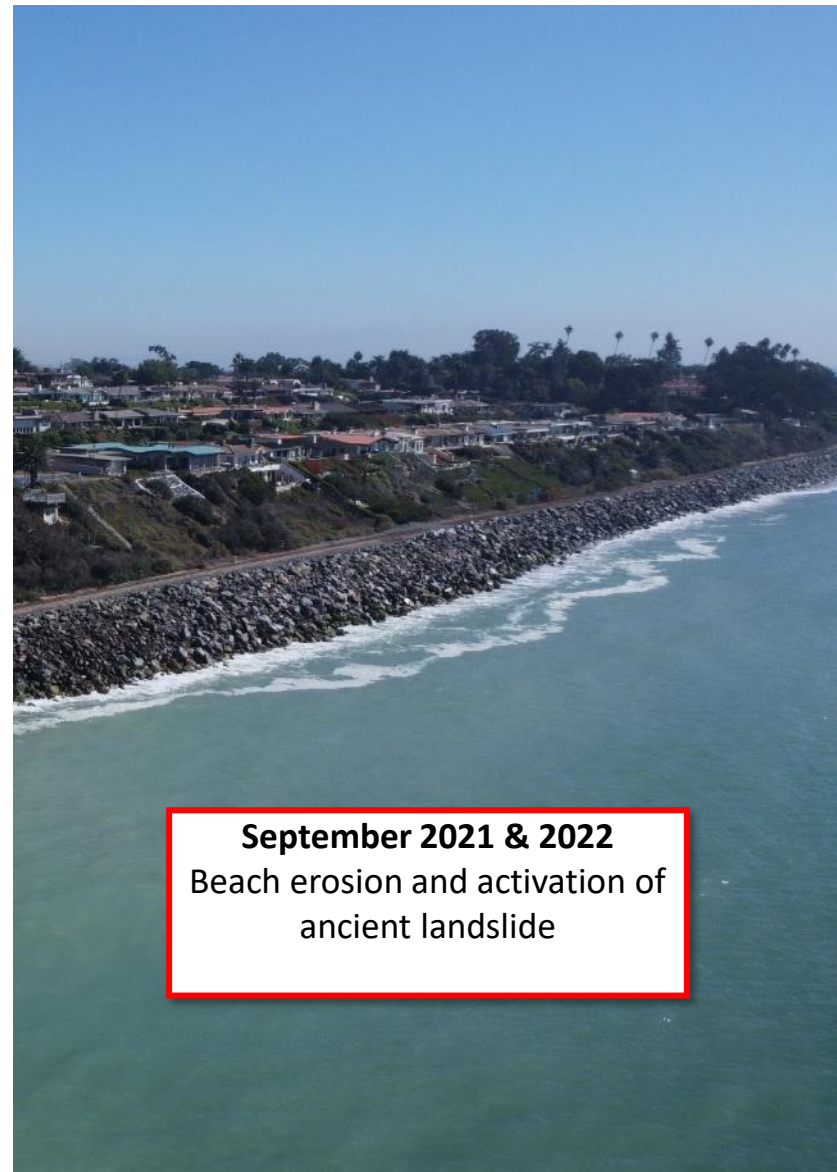
**September 2021 & 2022**  
Beach erosion and activation of  
ancient landslide

- Significant beach erosion activated historical landslide
- Tracks moved +28 inches laterally toward ocean
- Passenger train service suspended to stabilize tracks
- Placed +18,000 tons of riprap along 700 feet of track (counteracts mass of slide)
- Monitoring track and slope movement

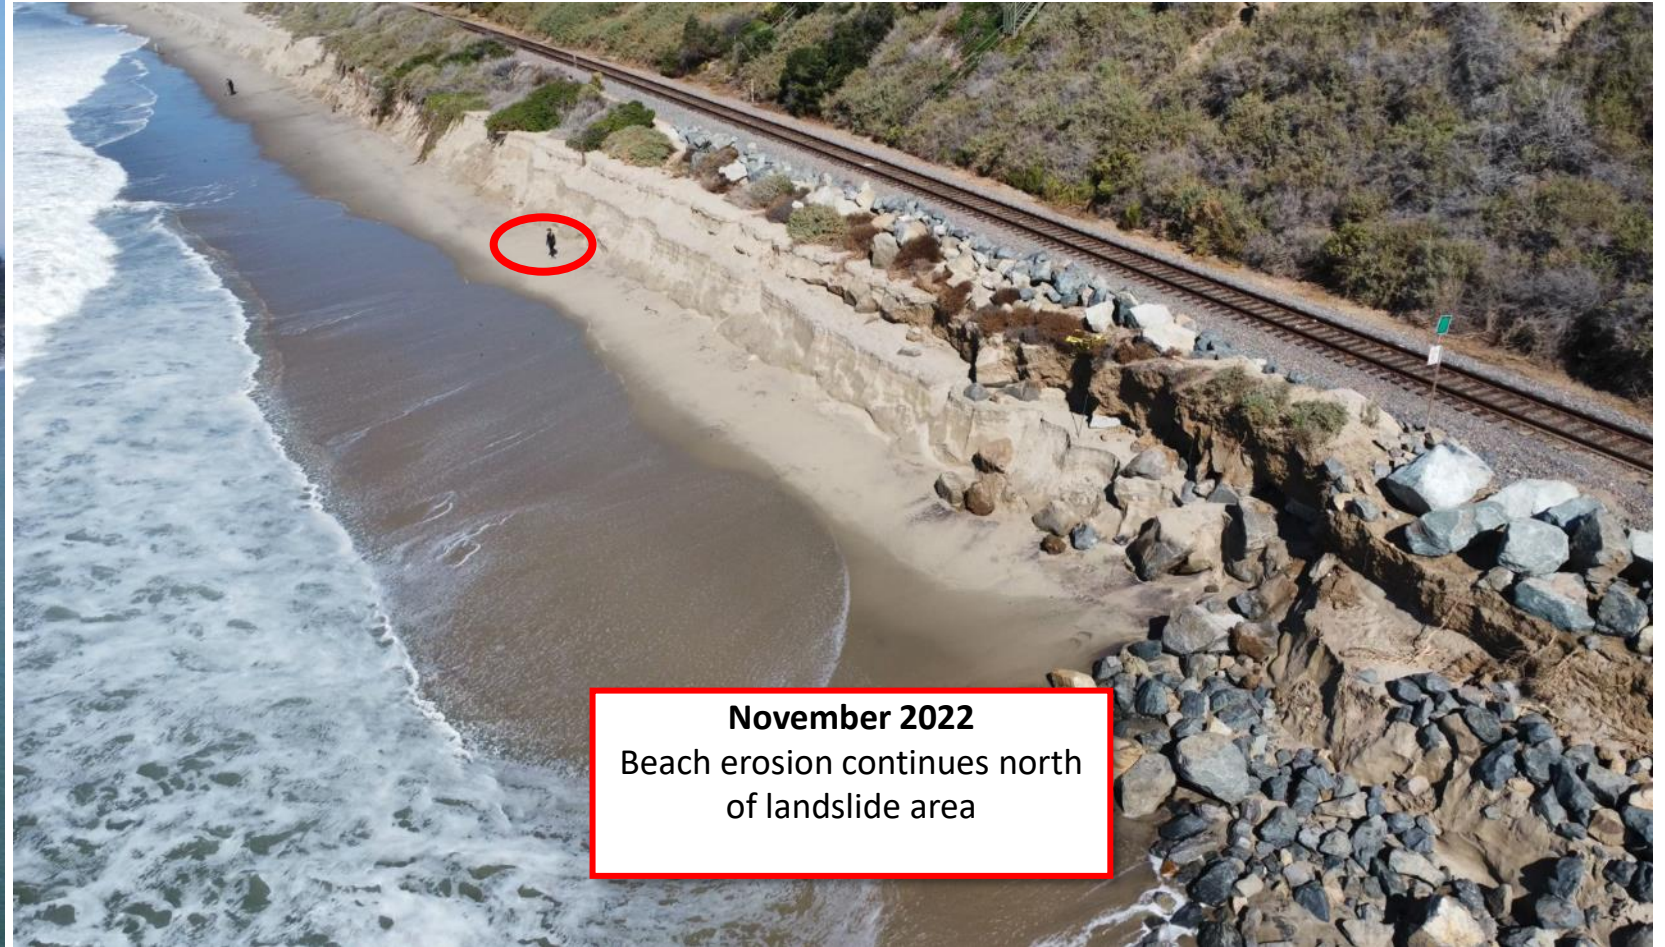
**November 2022**  
Beach erosion continues north  
of landslide area

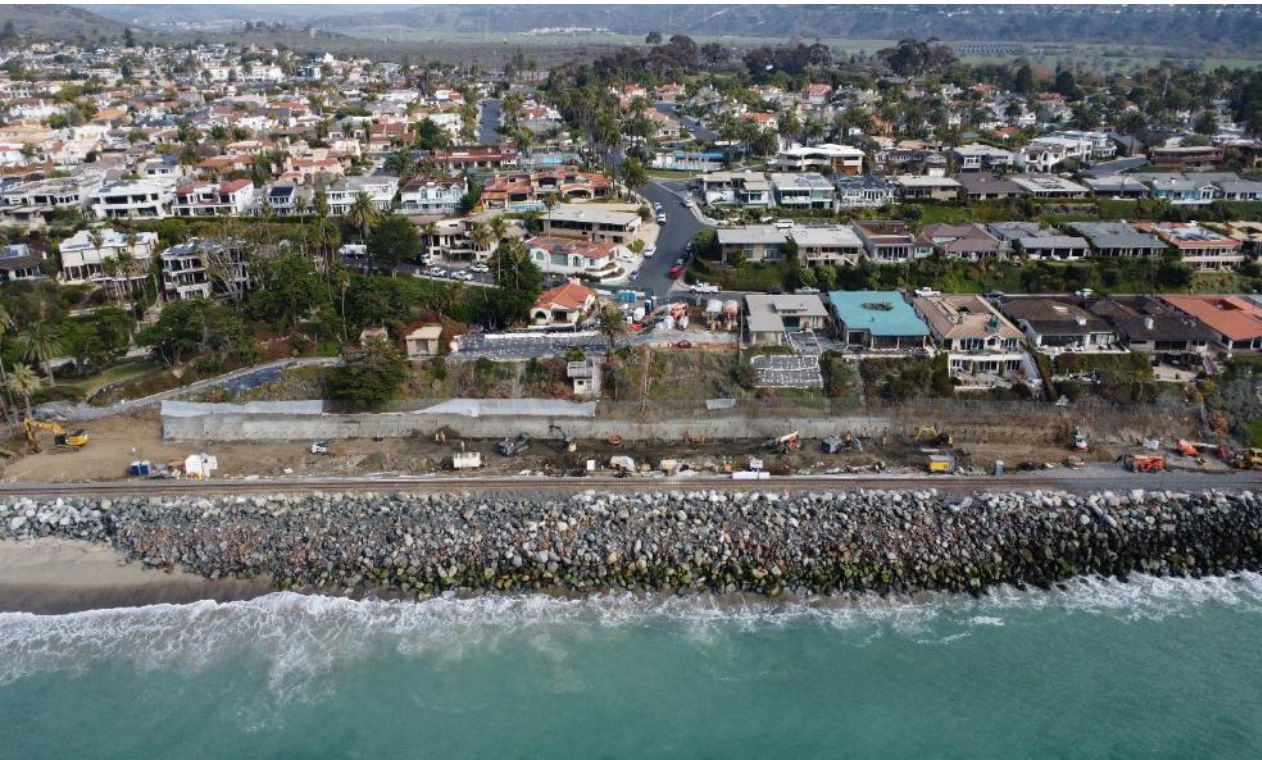
**December 15, 2022**

# Tieback Installation

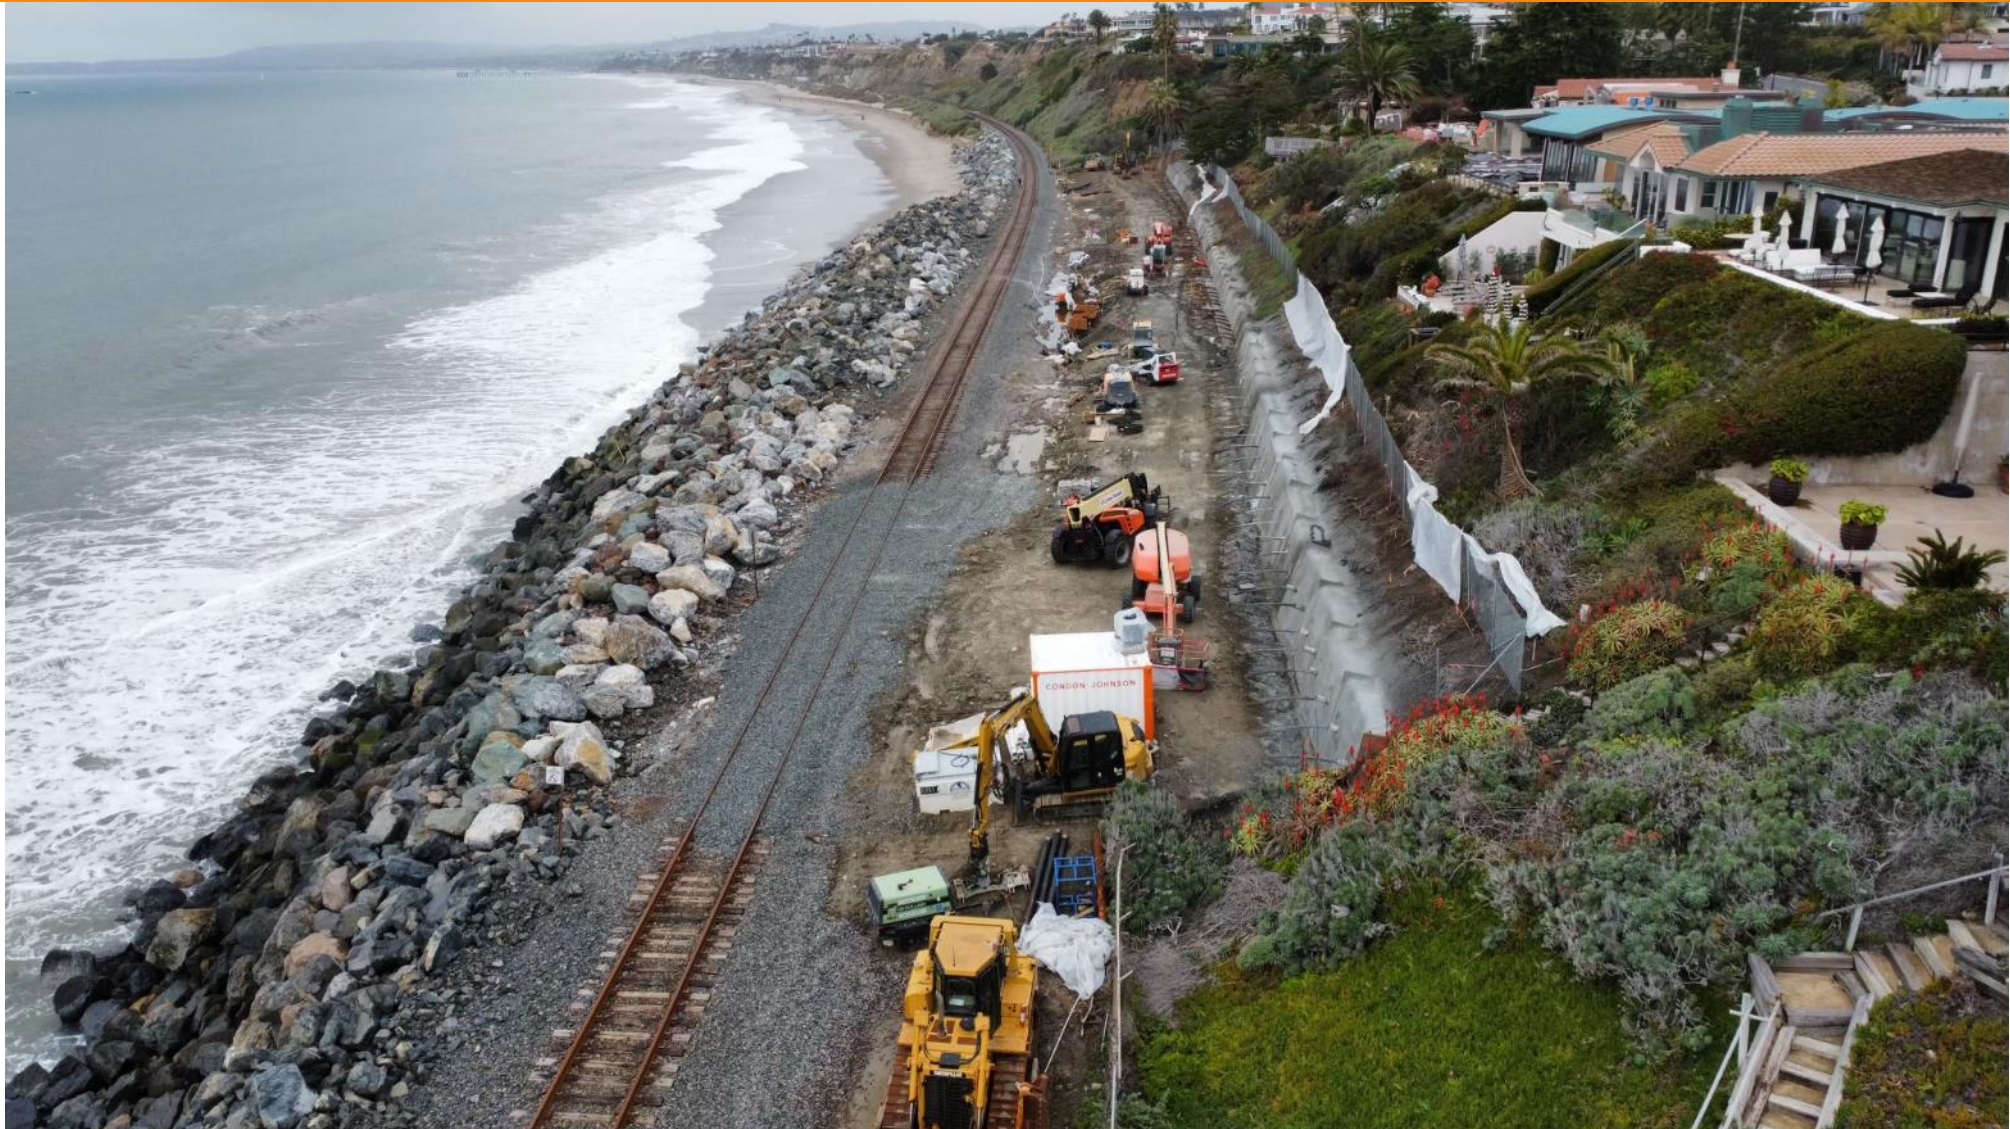
January 2, 2023

# First Level Grade Beams and Tiebacks Installed

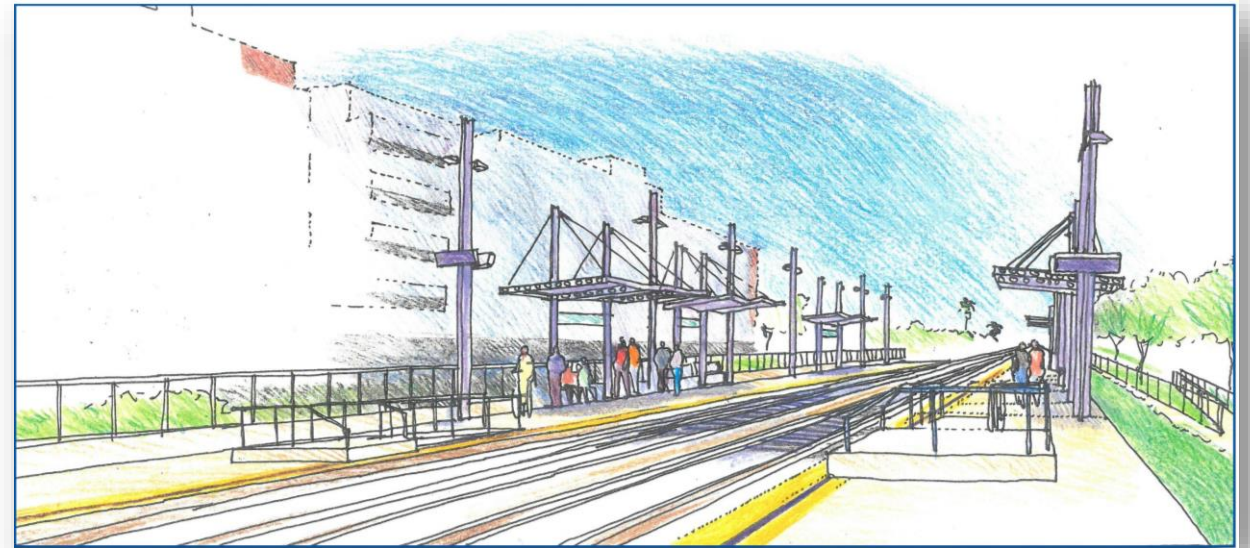
Rendering of station improvements

3,400 linear feet of new track
-

New platform and extension of existing platform
-

Improvements to crossings
-

New benches, shade structures, ticket machines
